NASA/TM-2014-218172 NESC-RP-12-00778

International Space Station (ISS) Orbital Replaceable Unit (ORU) Wet Storage Risk Assessment

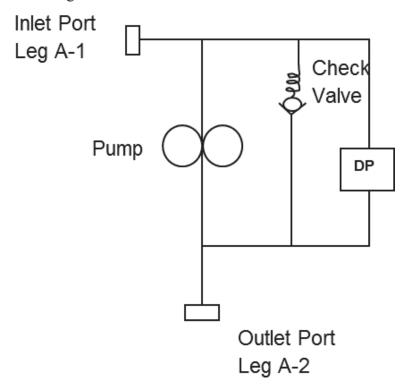
Figure 6.2-1. Component 3 Schematic

Component 3 (pump ORU) was sampled on April 29, 2013. A simplified schematic for Component 3 is shown in Figure 6.2-1.

The major elements of Component 3 are a pump, a check valve, and a delta pressure sensor. There are quick disconnects (QDs) on the inlet and outlet of the ORU. The ORU was pressurized with gaseous nitrogen at the inlet port to Leg A-1 and the sample was collected at the outlet port Leg A-2, where each leg represents the tubing on either side of the pump, check valve, and delta pressure sensor. The process was then repeated in reverse, using the same sample container, to capture any residual water. Total volume collected from Component 3 was 46 ml.

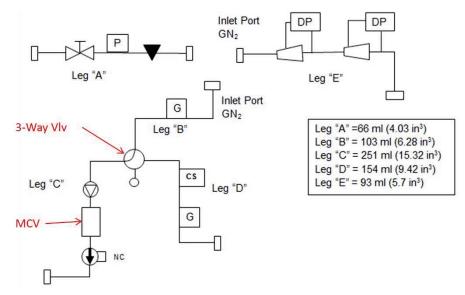
Figure 6.2-3. Component 1 Schematic with Leg Volumes

Component 1 (water ORU) was sampled on May 23, 2013. A schematic of Component 1 is shown in Figure 6.2-3. Component 1 comprises several separate subcomponents and 5 distinct legs defined for the purpose of sampling. Leg B interfaces to both Leg C and Leg D via a three-way valve, and the pressure source to sample from the Leg C and Leg D outlets was mated to Leg B. For this reason, the samples obtained are referenced as Leg B-C and Leg B-D. The water from Leg B-D was captured first, then the three-way valve was repositioned and the Leg B-C sample was taken in a new sample container. Leg E was captured separately, also in its own sample container. Leg A is stored dry, so no sample was taken. Figure 6.2-3 highlights the MCV in Leg C, which is discussed in Sections 6.2.2 and 6.2.3.

Leg C in Component 1 contains an MCV (see Figure 6.2-3). The purpose of the MCV is to add iodine to the water as it flows through the MCV cartridge, which contains a resin impregnated with iodine (the process by which iodine is loaded onto the resin is proprietary to the manufacturer, Umpqua Research Company (URC), Umpqua, OR). The Component 1 Leg B-C sample potassium concentration was significantly elevated (445 mg/l). If the concentrations of iodide and potassium are compared from the stoichiometric (i.e., molar basis) standpoint, then it is a close match for potassium iodide (KI). This result led the NESC team to question if KI was used during the manufacture and preparation of the MCV. The team asked HSWL to inquire from URC, who supplies the MCV to HSWL for integration into the flight water systems,

Component 1 Leg B-D had a bacterial count of 1.0 CFU/10 ml, and Water Cart 5 had a bacterial count of 27 CFU/20 ml (Section 6.2.2). Component 1 Leg C had an MCV that was the suspected source of iodine and iodide. Leg B was open to Leg C by way of a three-way valve (see Figure 6.2-3) and would have been expected to be free of microorganisms due to the iodine. Leg D was isolated from the MCV and would be more likely to have a positive indication of microorganisms and biofouling. The Leg B-D sample was collected first, by pushing water from Leg B through Leg D and collecting water from both legs together. The results suggest that the water without access to the MCV/iodine was able to maintain the microbial components, but proliferation did not occur. It should be noted that the low measured CFUs in Leg B-D could also have been due to the influence of iodine from Leg B, where the time between sampling and analysis was 48 hours. Iodine from Leg B, when mixed with microbially contaminated water from Leg D, could have reduced the microbial numbers and resulted in a false low CFU number. However, iodine concentration in Leg B-D was below detection limit (0.05 mg/l). Iodine was detected in measurable amount (4.8 mg/l) in Leg B-C, the sample taken after Leg B-D.

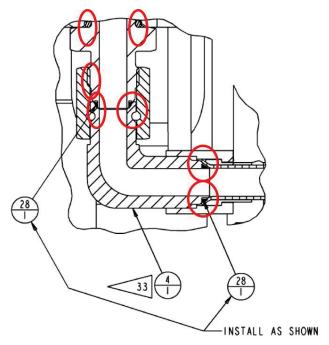
Figure 6.3-1. Example of Occluded Regions from the ISS ORUs Note: Red ovals and circles highlight areas of possible crevice corrosion.

An additional accelerating complication is the likelihood that some of these susceptible materials are part of a crevice with another material that is more electrochemically noble (e.g., graphite, silver, Inconel[®] 625, Ti-6Al-4V, or plated chromium). These materials can dramatically increase the rate and probability of crevice corrosion of the susceptible material [ref. 3]. The extent of this potential problem cannot be evaluated, because although the list of wetted materials for each ORU was provided, no information concerning what materials are connected was made available. HSWL was not willing to share that information with the NESC team due to proprietary concerns, so the extent of the potential for crevice corrosion could not be fully assessed and thus only general conclusions can be made with respect to crevice corrosion risk.

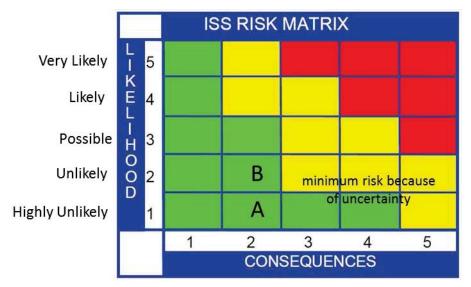
Figure 6.4-1. Minimum Risk Matrix for Crew Member Exposure to Harmful Microorganisms

The risk for human exposure to harmful bacteria is directly related to the overall risk of biological contamination plus the probability of the presence of harmful species. In the samples reviewed, none of the microorganisms detected present a health hazard to humans. Also, there are MCVs in both the OGA and the WPA, and additional measures to kill any bacteria, before water is retrieved for crew consumption. The placement on the risk matrix for crew exposure to harmful microorganisms is 1/2 (likelihood/consequence) assuming current procedures are followed, and a 2/2 on the assumption that there has been a contamination (see Figure 6.4-1). The consequence is assumed to be crew illness due to bacterial exposure.

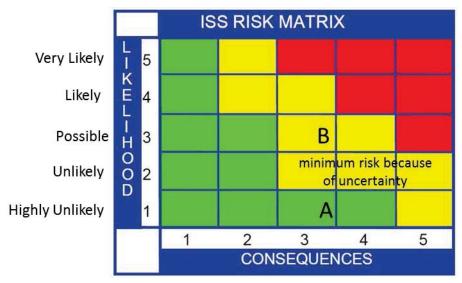
Figure 6.4-2. Minimum Risk Matrix for Biofouling

As in the case of crew exposure to harmful microorganisms, the risk for biofouling was assessed both for when the normal procedures are followed and in the event of contamination. The worst case consequence was assumed to be biofouling in the hydrogen ORU cell stack to the point of losing the use of the OGA. It was then assumed that if this occurred, a full crew complement of six could not be accommodated, resulting in a "significant impact to" or "loss of some mission objectives" (ref. Appendix J). This equates to a 3 or 4 on the risk matrix. If procedures are executed nominally, then a biofouling event on the hydrogen ORU is highly unlikely (i.e., 1 on the ISS risk matrix). However, if biological contaminants were to be introduced into the OGA or WPA, then the environment may be conducive to growth and possible biofilm formation. In this case, the likelihood rises to possible (i.e., 3 on the ISS risk matrix) (see Figure 6.4-2).

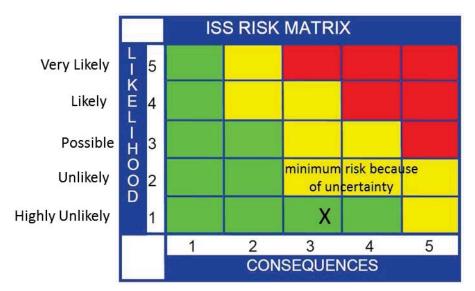
Figure 6.4-3. Minimum Risk Matrix for Corrosion

results, any microbial presence in a given ORU is *highly unlikely* (1 per the ISS risk matrix), assuming the same procedures used to limit contamination during servicing and sampling are followed. It follows that biofouling, MIC, and crew exposure are *highly unlikely* (1 per the scorecard) under this assumption. However, in the event of contamination taking place, the environment in the system is conducive to biological growth and biofouling and MIC are *possible* (3 per the scorecard); because the bacterial species observed in the samples are benign to humans, and more importantly, there are microbial controls to protect the crew (e.g., MCVs), the risk to crew health would be *unlikely* (2 per the scorecard). For the reasons described earlier, corrosion (not including MIC) is *highly unlikely* (1 per the scorecard).

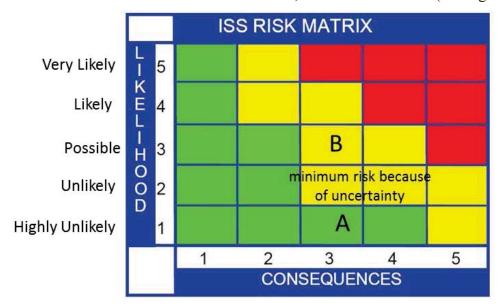
Figure 6.4-4. Minimum Risk Matrix for MIC

The risk for MIC, as described in Section 6.2.4, correlates with the risk for biofilm growth and biofouling. Two of the three requirements for MIC, electrolytes and susceptible materials, are present, but the samples from the two ORUs indicate microorganisms are not. Because conditions within the ORUs may be conducive to bacterial growth, and the other factors necessary for MIC are present, the risk for MIC assuming a microbiological presence is 3/3 on the ISS risk matrix. If there is no microbial introduction, then the risk is a 1/3 (see Figure 6.4-4).

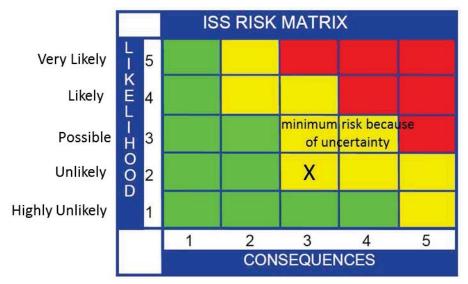
Figure 6.4-5. Minimum Risk Matrix for Long-term Wet ORU Storage (overall)

Overall, the risk posed by long-term wet ORU storage is driven by the risk that microorganisms are introduced into the system after the last disinfection process (if there is one). Risk is minimal if it is assumed that no contamination will take place, but although the procedures in place have proven, at least for the two ORUs sampled, that biological contamination controls are sound, human error and equipment failure may undermine those controls. Therefore, the overall risk assessment must attempt to determine the likelihood of a failure in contamination control, and that is judged to be unlikely. If the consequence is assumed to be significant impact to mission objectives, then the position on the risk matrix is 2/3 as shown in Figure 6.4-5.
